Manhole Inspection Summary

Manhole # S47AA_030MH

Insp Date: **6/20/08 10:10 AM**

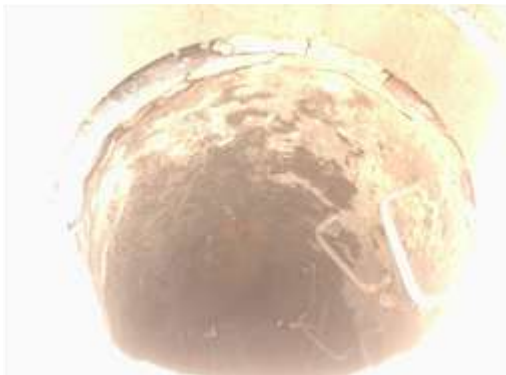
Defect 2

Condition: ☐ Sound ☐ Cracked ☐ Root Intrusion ☒ **Loose Brick** ☐ Deteriorated

loose bricks

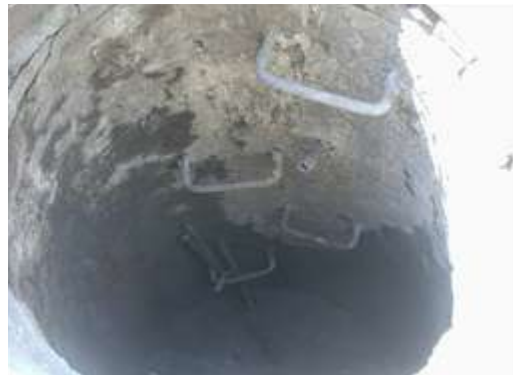
Defect 1

Infiltration: ☐ None ☒ **Joint** ☐ Cracks ☒ **Mortar** ☐ Roots ☐ Wall

infiltration

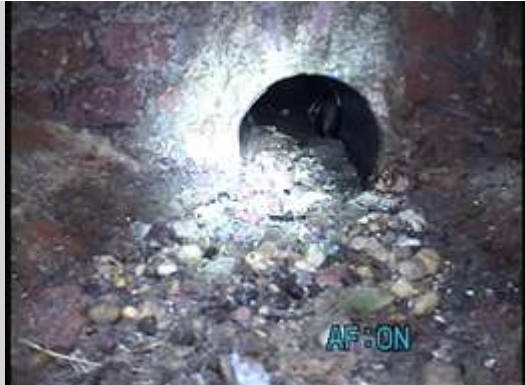
12 O'Clock Outflow

8 in. Circular Gravity Sewer
Pipe Out @ 12 O'Clock

Infiltration: **None** Pipe Seal Cond: **Sound**
